# CEMENT DRAIN TILE

# Cement Drain Tile

## Lasting Qualities

An Investigation  
Conducted by the  
INFORMATION BUREAU  
UNIVERSAL PORTLAND CEMENT CO.

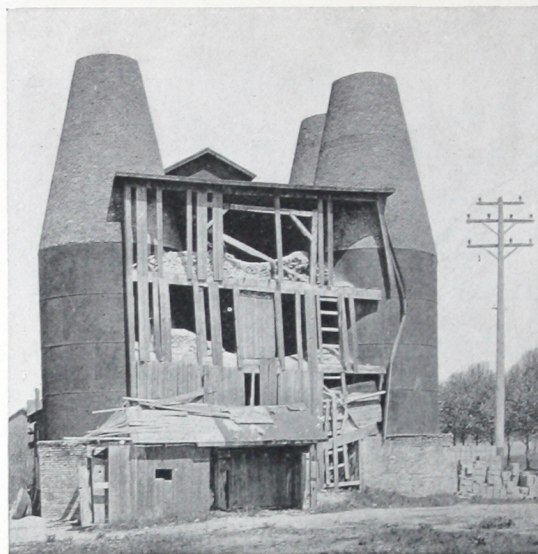
cement for making pipe. Fig. 1 shows the abandoned plant in its present condition.

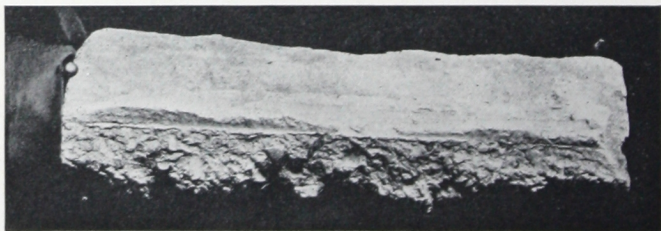
at the side of the road ever since. Three of these pipe were shipped to Chicago and tested to determine their strength. They averaged 100,000 pounds total for the 2 ft. length. Fig. 2 shows a fracture of one of these

pipes as it came from the testing machine. It is interesting to note that a large percentage of the stones have been fractured, which indicates that the concrete is in excellent condition.

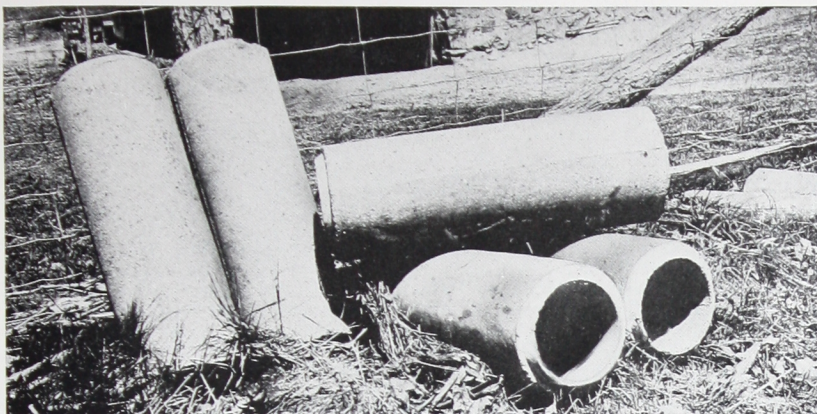
Fig. 3

Five miles from South Bend on South Bend Avenue, Mr. Jacob Young placed five pipe 8 inches in diameter across his driveway in the early eighties. (Fig. 3.) In 1899 the road was graded, the pipe taken up and they have lain

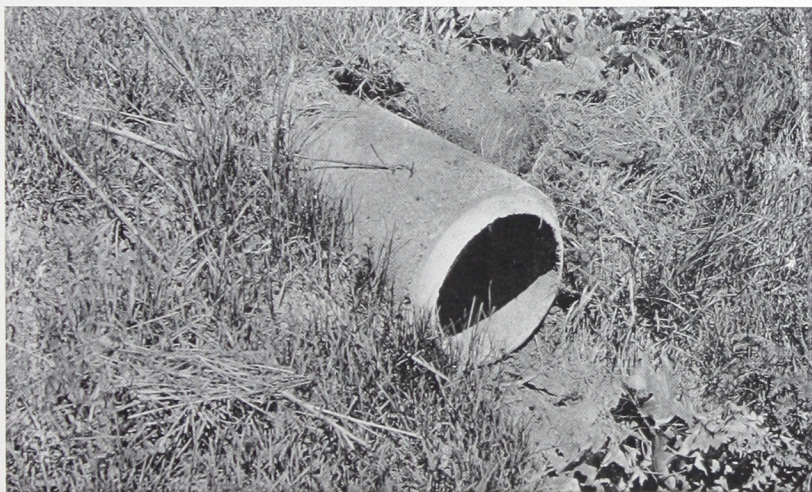
Fig. 4

At Mr. Daniel Young's farm, just beyond that of his brother, Jacob, another culvert made of 10-inch pipe was placed across the road in 1884. These pipe are also in perfect condition. (Fig. 4.)

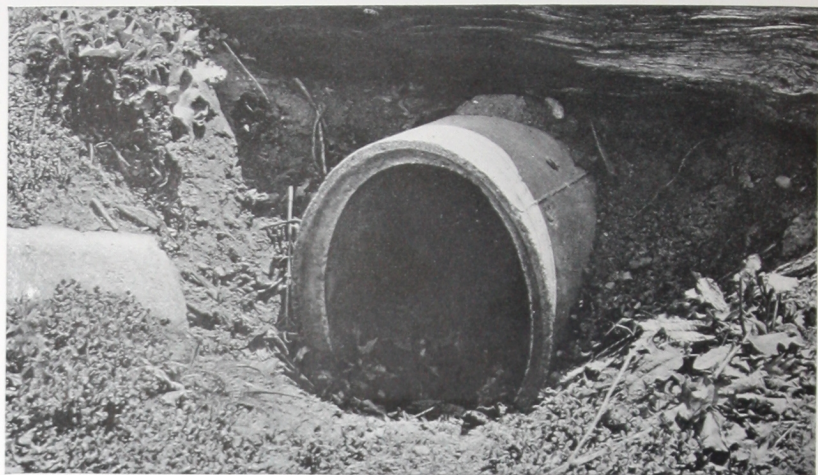
Fig. 5

Under the road in the same vicinity are about fifteen large flat-bottomed pipe, size 22" x 28" (Fig. 5), also placed in 1884, which are in an excellent state of preservation.

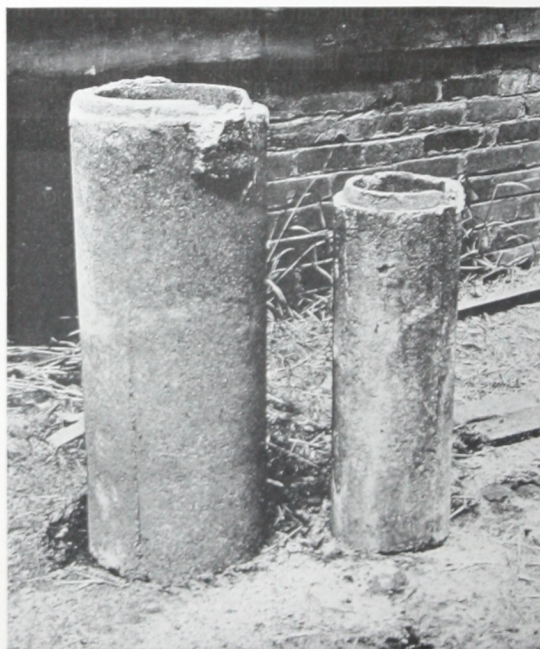
removed, and some are lying around the lumber yard today. Fig. 6 shows two of them, one of 6-inch diameter and the other of 9-inch diameter.

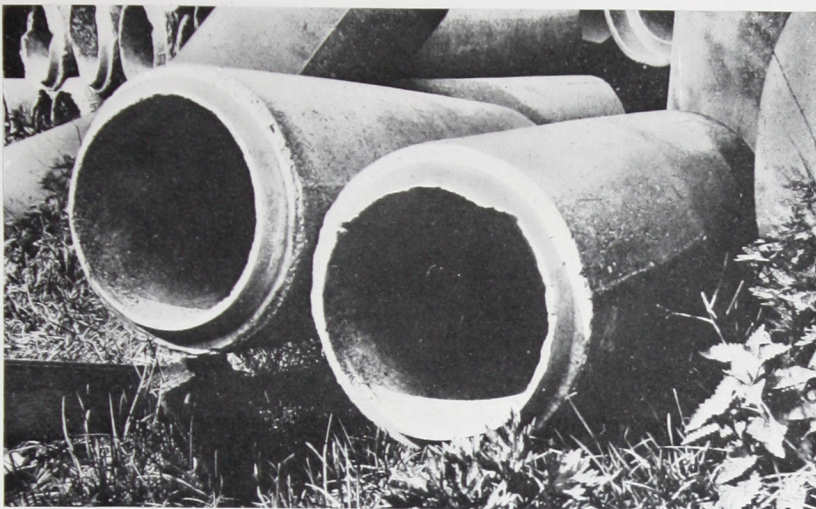
Fig. 7

from three hundred to one thousand people were employed. At that time it became necessary to repair the street and enlarge the drain as the fast growing population required a sewer of larger capacity. It was then removed by Hoban & Roach and many of the pipe resold. A few are left in their yard (Fig. 7) and all are in perfect condition.

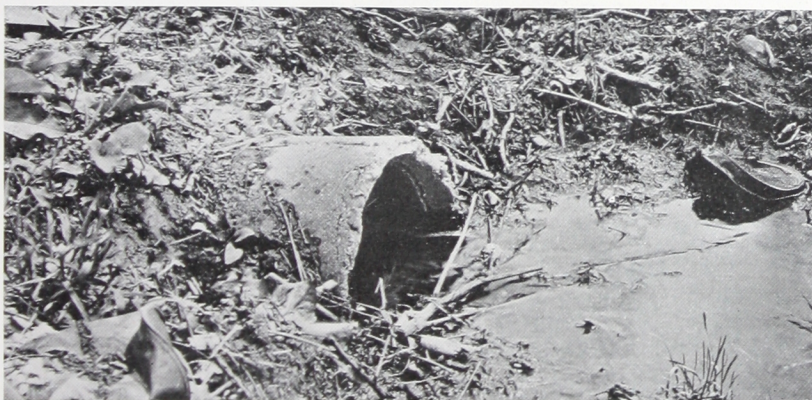
Fig. 8

Another lot of 18-inch cement pipe is used on one of the Notre Dame farm roads and has been in place for twenty years. (Fig. 8.) Under another part of the same road two parallel lines of 22" x 28" oval pipe

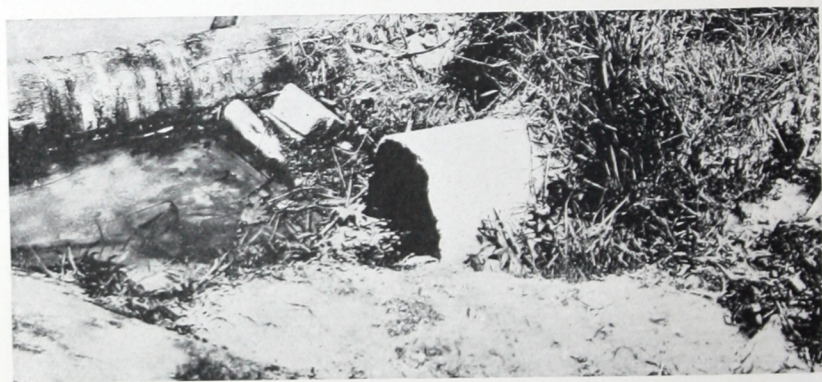
Fig. 10

A line of 12-inch pipe at least twenty years old, empties into Notre Dame lake (Fig. 10) and carries the surface water from the adjacent hill slope.

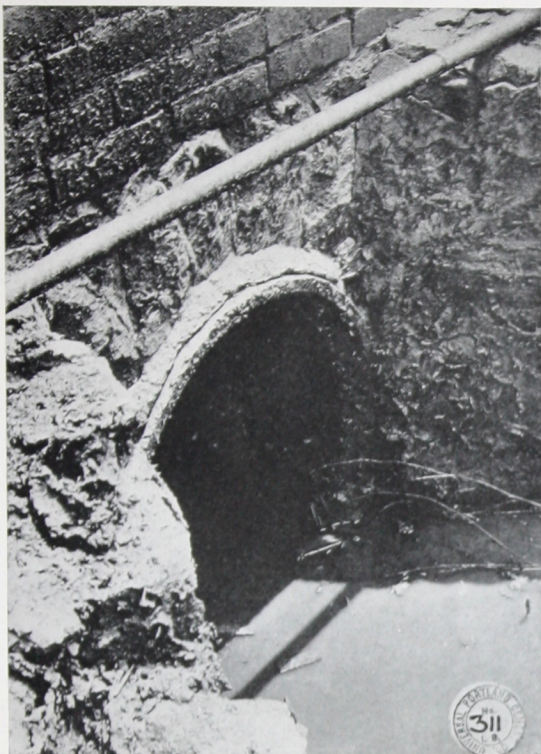
Fig. 11

The pipe made in South Bend were shipped out for use in neighboring towns and for highway culverts. At Mishawaka a large number of these pipe were used with entire satisfaction. The Dodge Manufacturing Company has a concrete sewer, size 22" x 28", the inlet of which is shown in photograph Fig. 11. According to Mr. Hos-

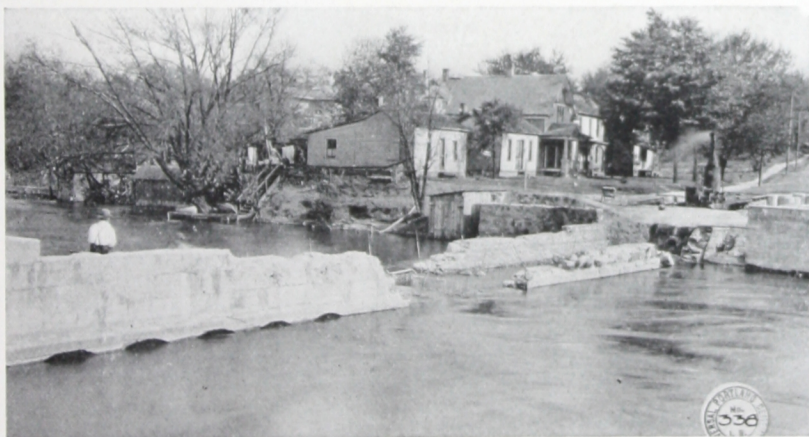
Fig. 12

Prior to 1883 a large number of 18-inch pipe were laid under Race street, Mishawaka, and through the old head gate at the foot of the street. (Fig. 12.) A new head gate was placed and as the old one interfered with the flow of water, it was removed and the pipe taken out to be relaid elsewhere. (Fig. 13.) The pipe are in perfect condition and the web-like "water marks" from the removal of the mold can still be seen on their inner surface. (Fig. 14.) Mr. G. F. Stoeckinger, a sewer con-

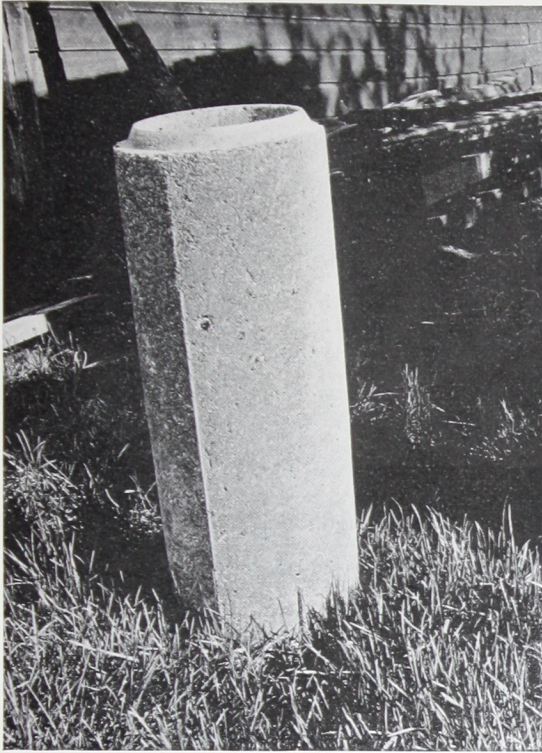
In about the year 1888 Mr. Adam Klaer bought 8-inch pipe from South Bend which he placed as a culvert in front of his home in Mishawaka. In 1903, when the street was paved, the pipe were taken up and Fig. 15 shows one of them in perfect condition.

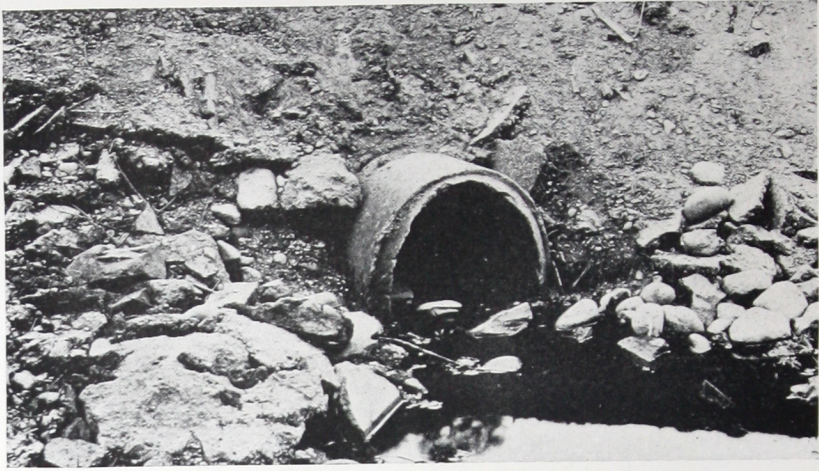
The pipe which is shown in Fig. 17 is 15 years old and is located at Hamblin avenue and Putnam street in Battle Creek and drains the water from an open ditch into the Kalamazoo River. Fig. 18 shows two lines of pipe, one 18-inch diameter and the other 24" x 30" oval. The large pipe were laid twenty years ago, and the smaller pipe are of about the same age. Fig. 19 shows an 18-inch pipe, first placed in 1880 at Niles, Michigan, and recently removed from a sewer which, according to Mr. Fogus, superintendent of the Board of Public Works, is still doing service. In the same vicinity is a line of 24" x 30" pipe, made at South Bend, and in as good condition as the one shown in the photograph.

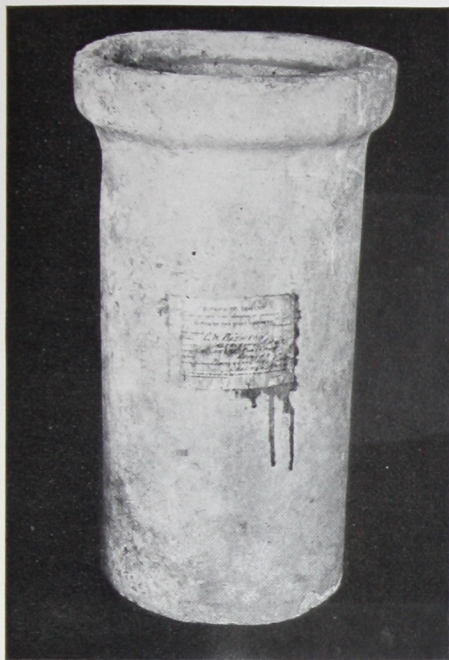
Brooklyn, N. Y., at one time used cement sewer pipe exclusively, the first pipe being placed about 1861. Today, over 400 miles of cement pipe are in use and giving good service. Fig. 21 shows a pipe which had been in use for nineteen years and was in good condition when removed in 1909.

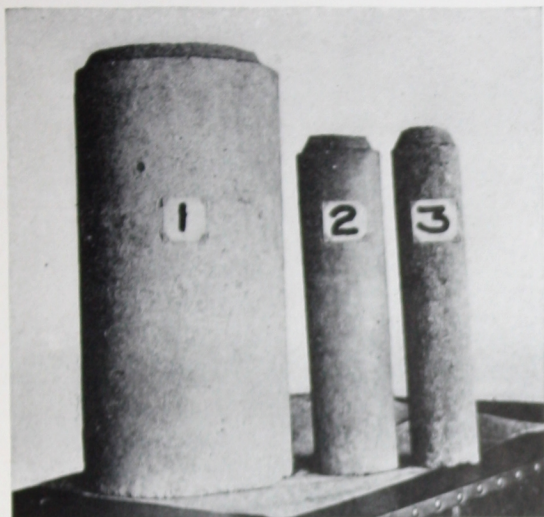
Fig. 29 shows three concrete pipe. No. 1 was made at South Bend, Indiana, and placed in a highway culvert about 1888, and was removed after serving 18 years. No. 2 is a 4" x 24" cement pipe taken from the farm of Mr. Howard Fitz, at Monterey, Minnesota, and had been in service since 1883. No. 3 is a 3" x 24" pipe from Farmers City, Illinois. The pipe was originally placed in 1871 to drain a cellar under Bean's Hall. After serving fifteen years it was removed to make way

for a larger drain. A portion of these pipe were relaid and are still in service. These examples are cited as practical demonstrations of the remarkable lasting qualities of concrete pipe.

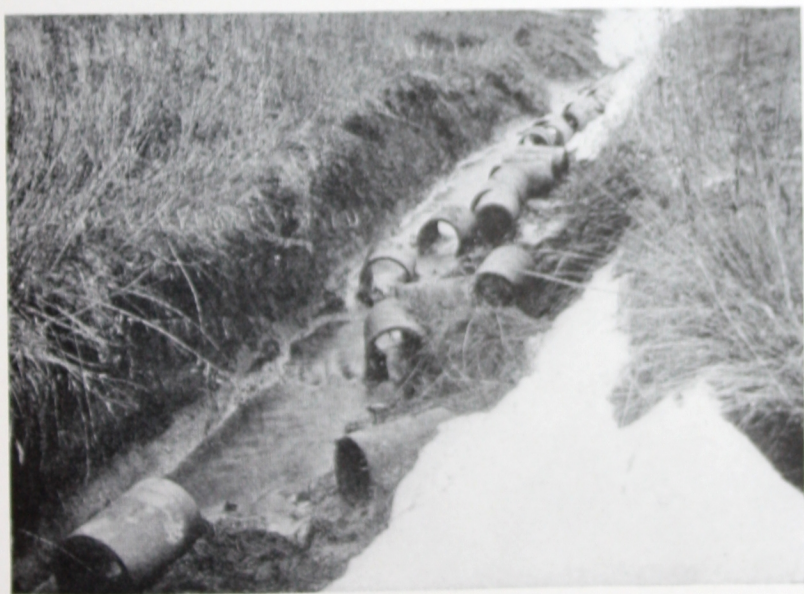
Fig. 30 shows some 15-inch cement tile which were laid in a county drainage ditch near Armstrong, Iowa, washed out the first season, and have since been subjected to the most severe ditch conditions of alternate freezing and thawing. This picture serves to illustrate forcibly the lasting qualities of concrete pipe. It also shows the need of a concrete head wall (Fig. 31) which would undoubtedly have prevented the washout.
